Case 244 : Narrative

Case Vehicle (A): 1999 Chrysler
Type: Sebring, 2-door convertible
Driver: 47-year-old male
CDC: 12-FYEW-5

CASE NO.: 244-01

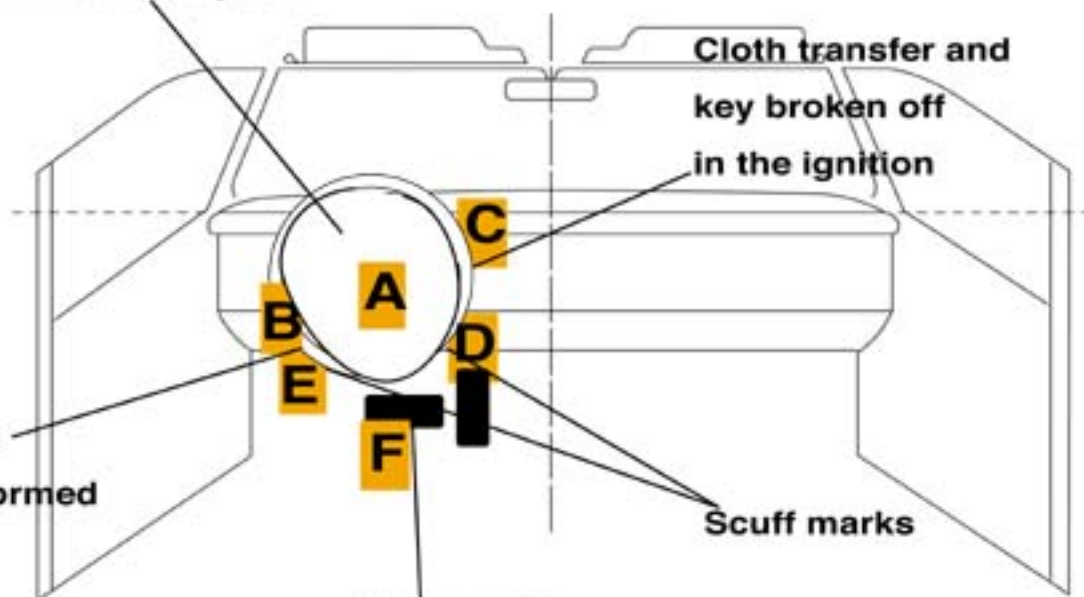
Scuff marks

**Brake pedal
deformed**
